* AGS Accelerator Division *
* Technical Note # 225 *

Gas Load (Q) Measurements of the AGS Ring Vacuum Sectors

H.C. Hsueh and M(Sanki) Tanaka

07-November-85

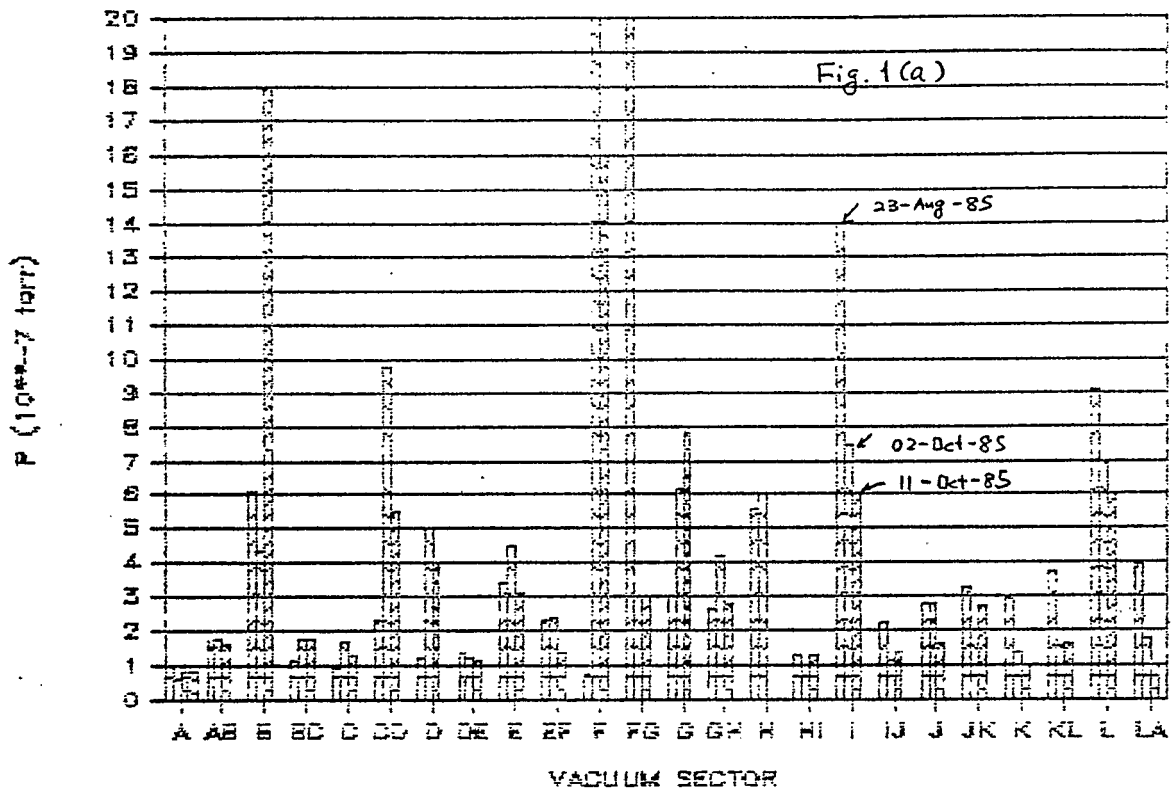
Measurement

The pressure P before turning off the ion pump H.V.. and the gas load Q have been measured several times for each vacuum sector. The results are listed in Table 1. and plotted in Fig.1. Based on a single chamber measurement at the vacuum lab, the outgassing of 10 standard ring vacuum chambers (i.e. 1 sector) after one week of pumping is estimated to be approximately 2×10^{-6} torr-l/s which is in reasonable agreement with the results for more than half of the sectors. However there are

A:
AB: Leak near B3 by VSCAN; found small leaks(10^{-8} range) at A-20 box on Oct. 14
B: Still in the process of pumping down from the B-10 cavity repair; the high outgassing of 1×10^{-4} Torr.l/s is due to the current transformer at B-5 (this is consistent with the measured outgassing in lab. by V. Castillo)
BC:
C: May be due to the outgassing of the bump coil installed at C-13 in September
CD: May have leaks around C-20 pipe
D: May be due to the outgassing of the bump coil installed at D-7 in September
DE: May have small leak around D-19 by VSCAN
E: Small leak around E-9 by VSCAN
EF: Area worked on in September; more ion pumps are on line
F: No measurement due to local controlled turbo at F-10 box
FG: Leak at G-3 bellow; found leak at F-14 bellow on Oct. 15
G:
GH: Small leak near G-19 by VSCAN
H: Leaks at H-12 and H-13 bellows were repaired
HI: Leaks at H-16, H-17, H-19 and I-3 were found
I: Small leaks were found at I-4, I-8 and I-11

IJ: May have leaks near I-17 and I-20 by VSCAN
J:
JK: May have leaks near K-2 by VSCAN
K: May have leaks near K-9 by VSCAN
KL:
L: Have leaks near L-6 by VSCAN
LA: May have leaks near L-17 and L-19 by VSCAN
